TRAFFIC SAFETY STUDY

ACCIDENT LOCATIONS

CASCADE COUNTY, MONTANA

DEPARTMENT OF JUSTICE CONTRACT NO. 89-06-02-1

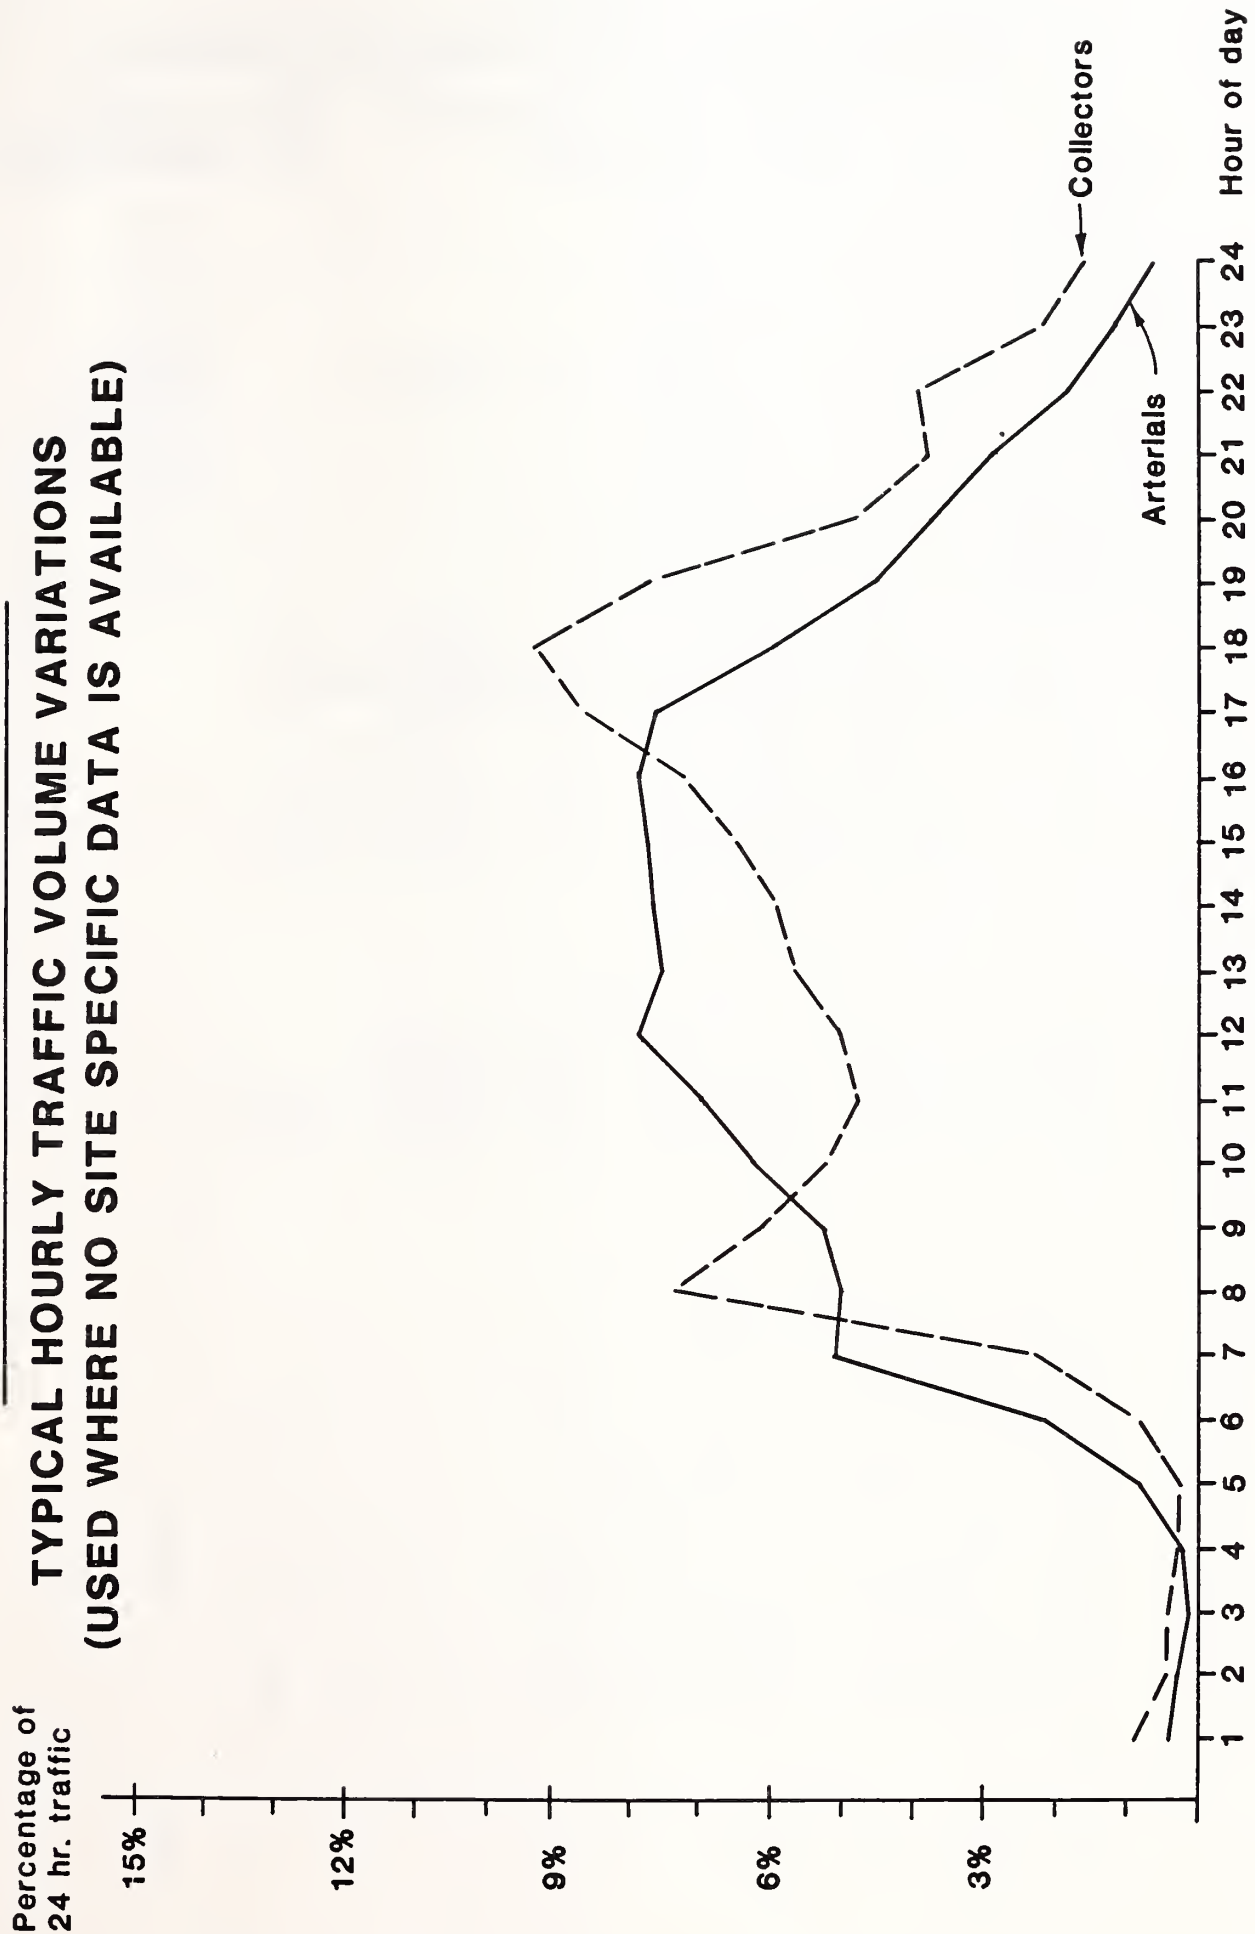
FIGURE 2

TYPICAL HOURLY TRAFFIC VOLUME VARIATIONS  
(USED WHERE NO SITE SPECIFIC DATA IS AVAILABLE)

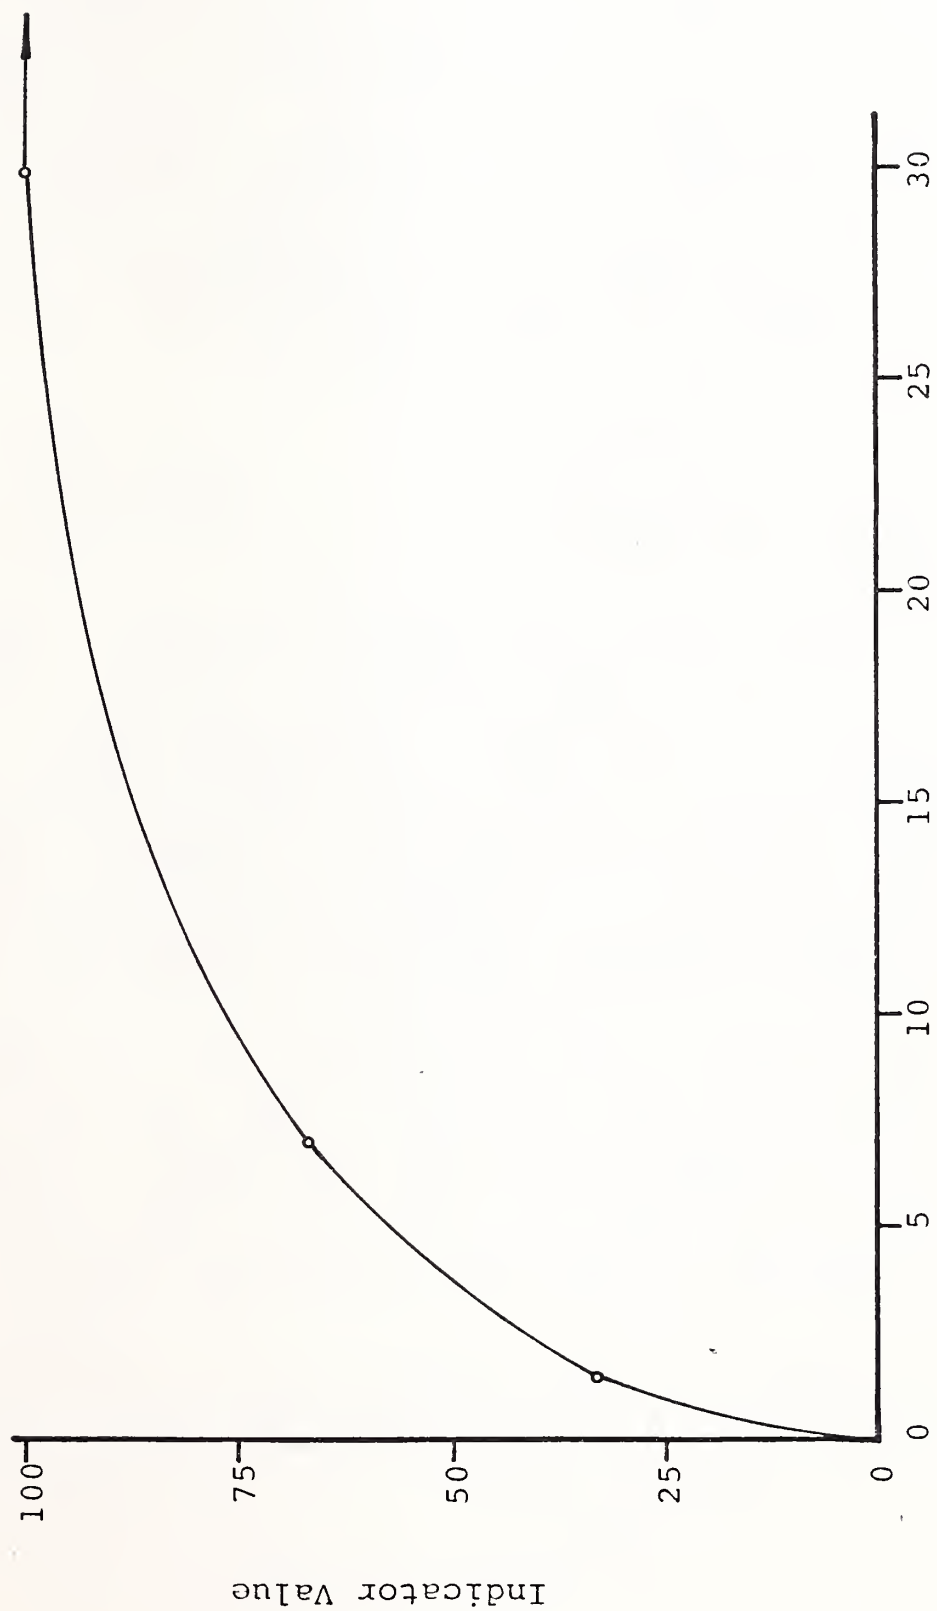
Figure 3 Indicator Values for Number of Accidents.

No. of Accidents per Year (3 year average)

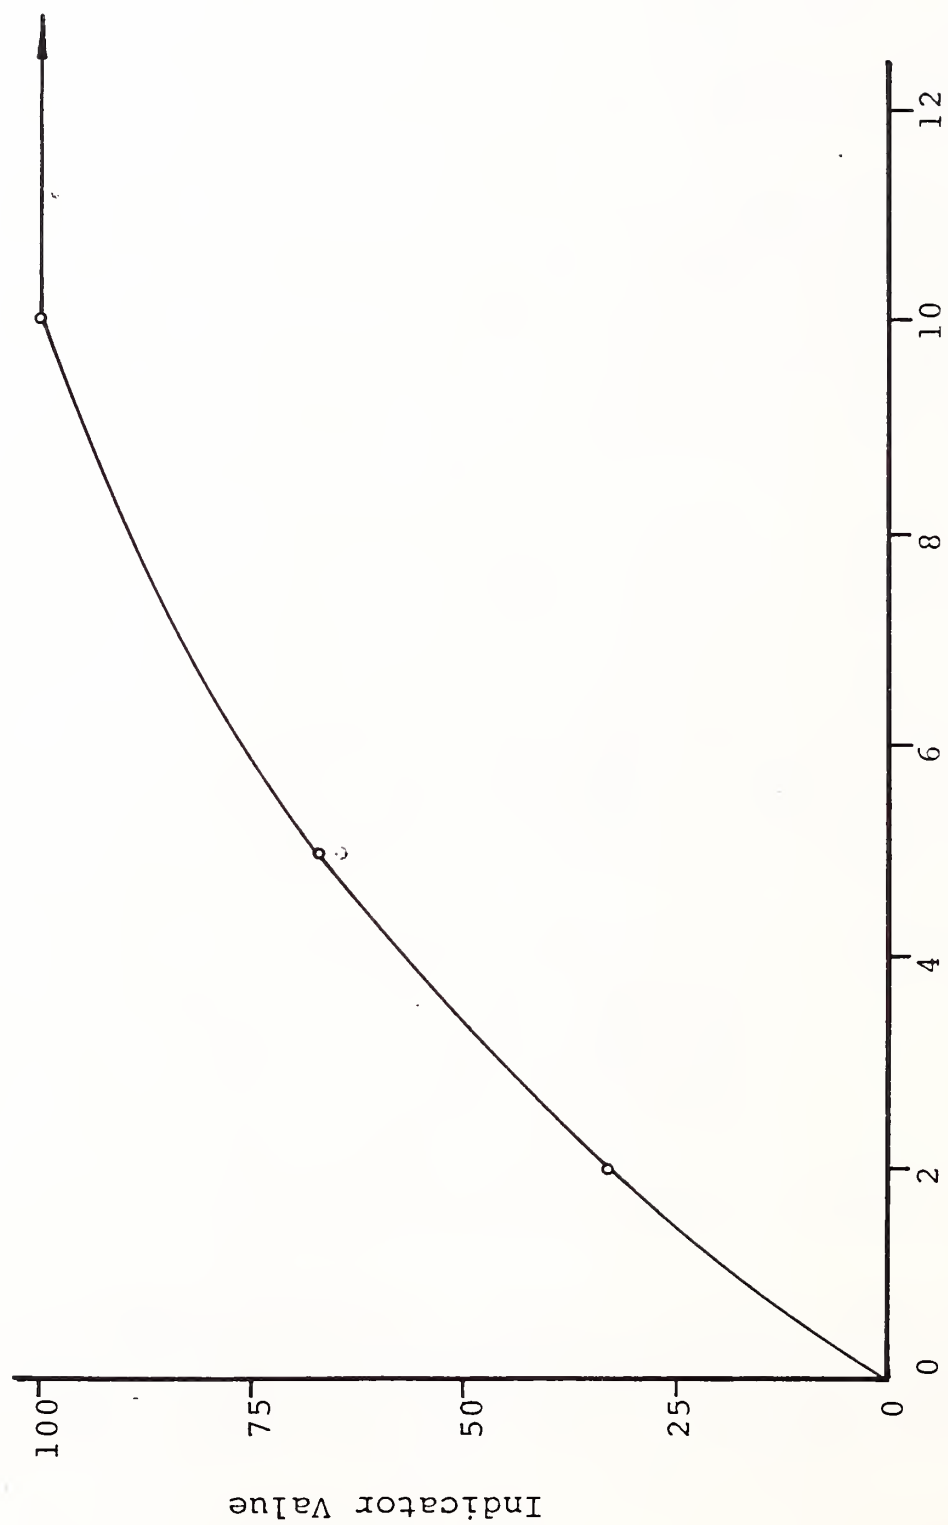
Figure 4 Indicator values for Accident Rate.

Accidents per Million Entering Vehicles (3 year average)

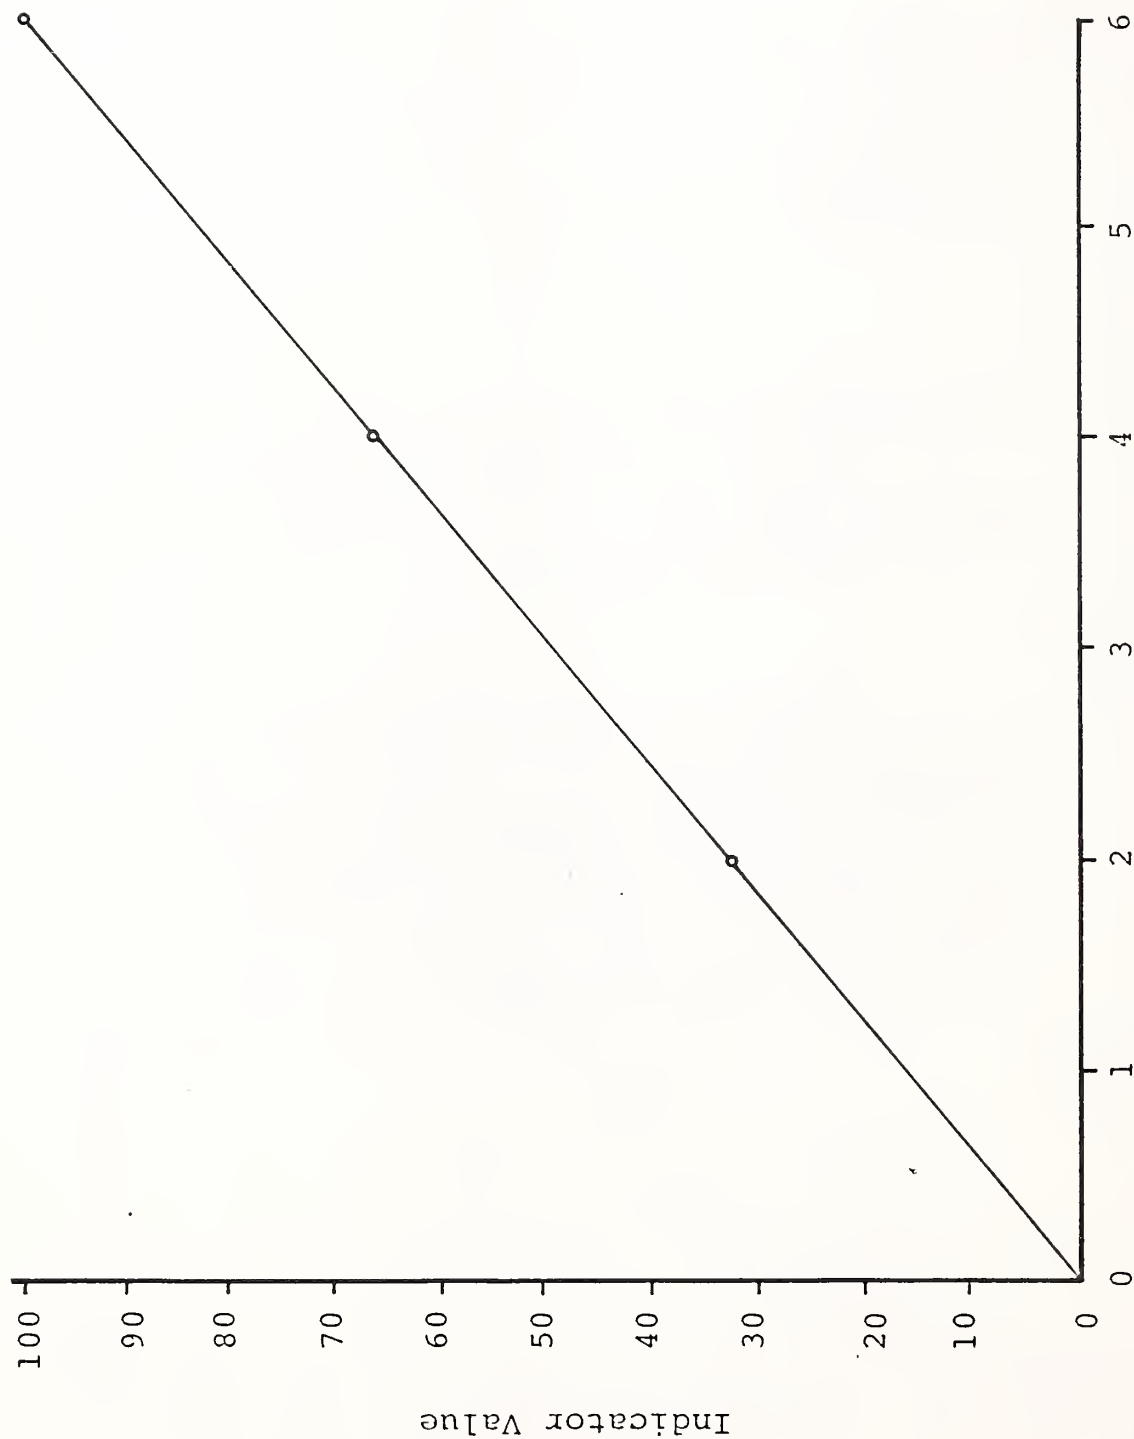
Figure 7 Indicator values for driver expectancy.

Driver Expectancy Problems Rating

Figure 7 shows the relationship between Driver Expectancy Problems Rating and Indicator Value. An Indicator Value is determined for each approach to a particular location. Then the weighted average of the two highest Indicator Values is determined and this value is used as the Indicator Value for that location. The highest Indicator Value is weighted 2.0 and the next highest Value is weighted 1.0

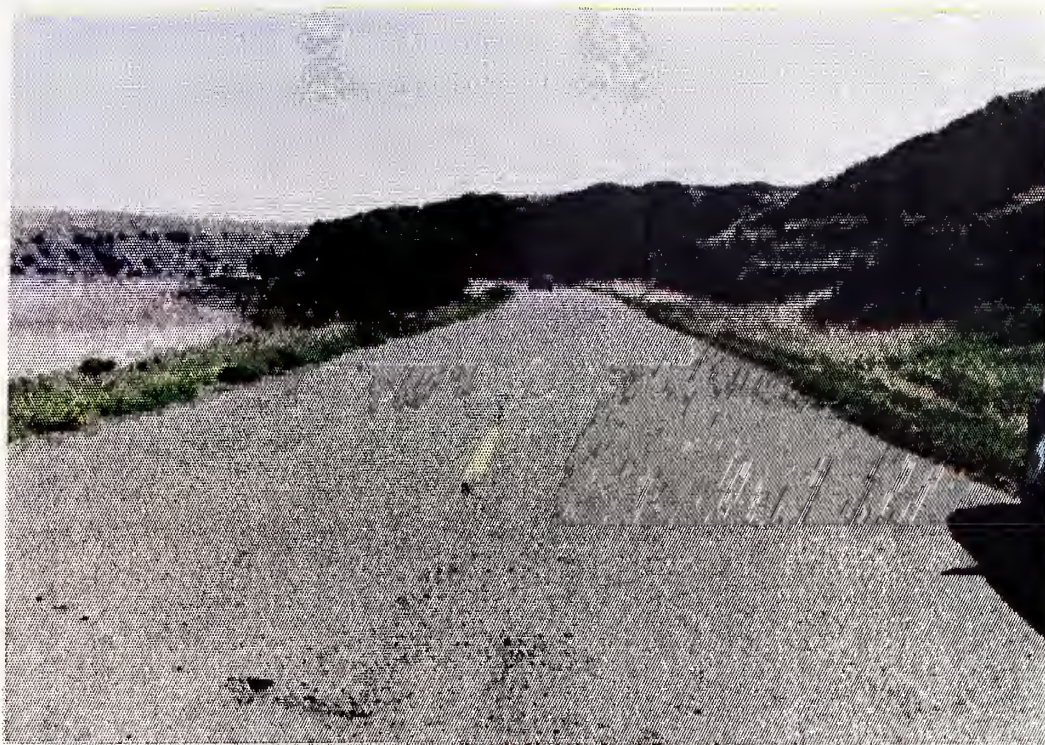
SITE 1: On Giant Springs Road approximately .35 miles east of Giant Springs State Park looking east. This location is just 200' west of the west border of Site 1. Note the site distance restriction created by the tall bush on the north edge of Giant Springs Road. (1/14)

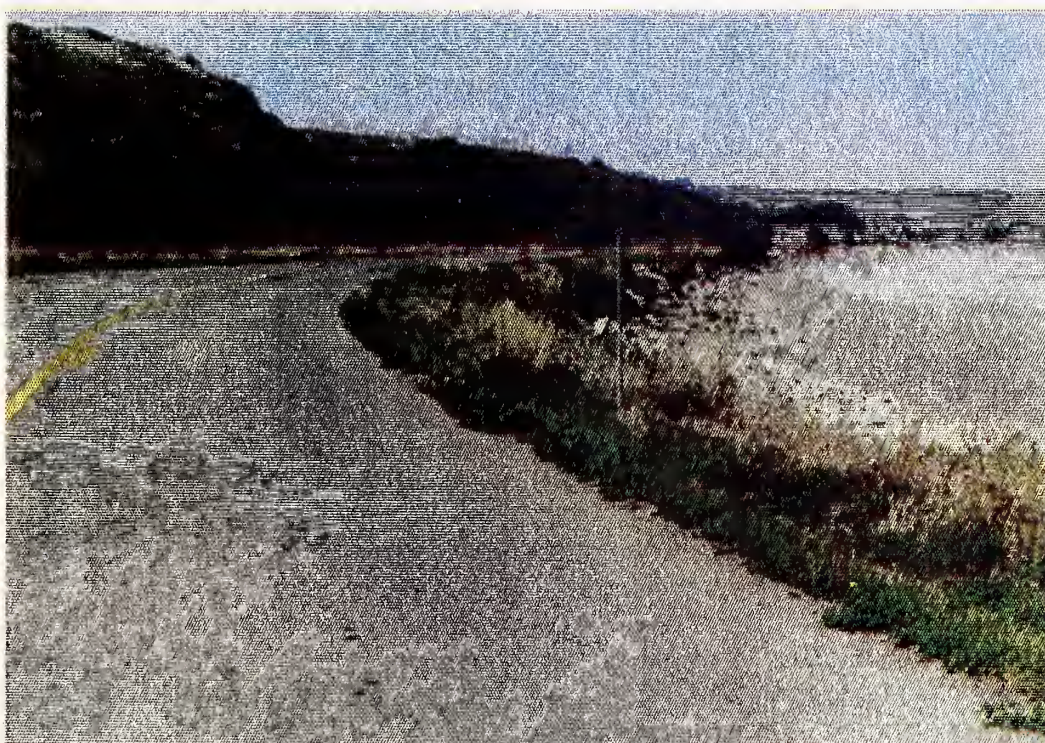
SITE 1: Taken 500' east of the west site boundary looking west. There is a red pickup truck emerging from behind the bush. (2/3)

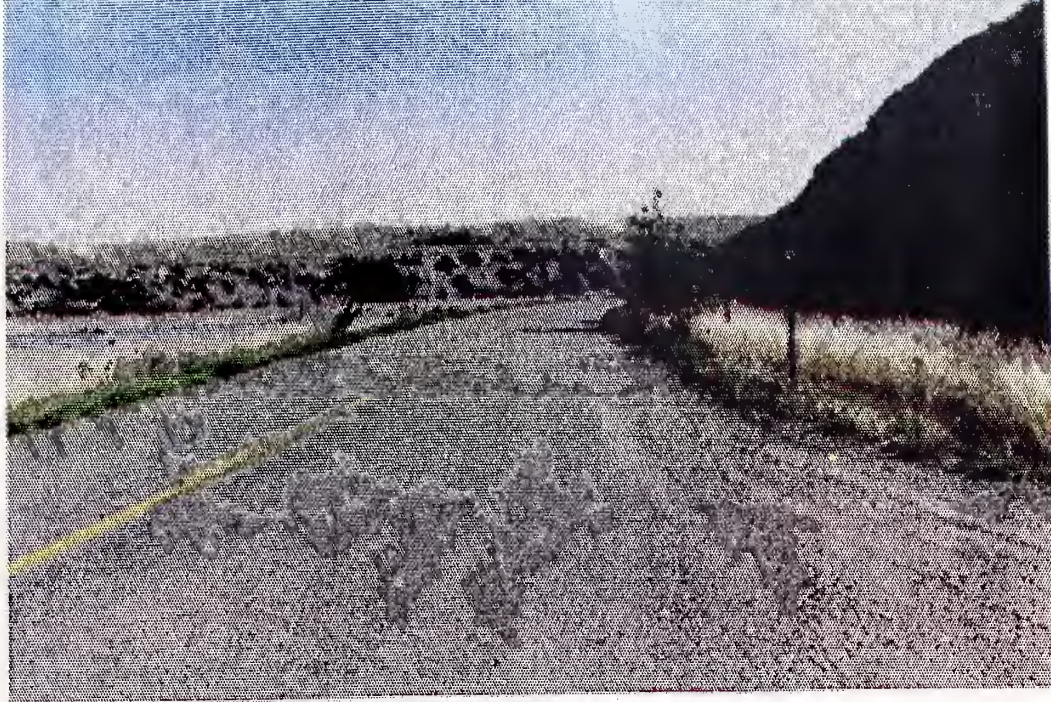
SITE 1: On Giant Springs Road approximately .5 miles east of Giant Springs State Park looking east. This location is approximately 400' east of the west boundary of Site 1. (1/16)

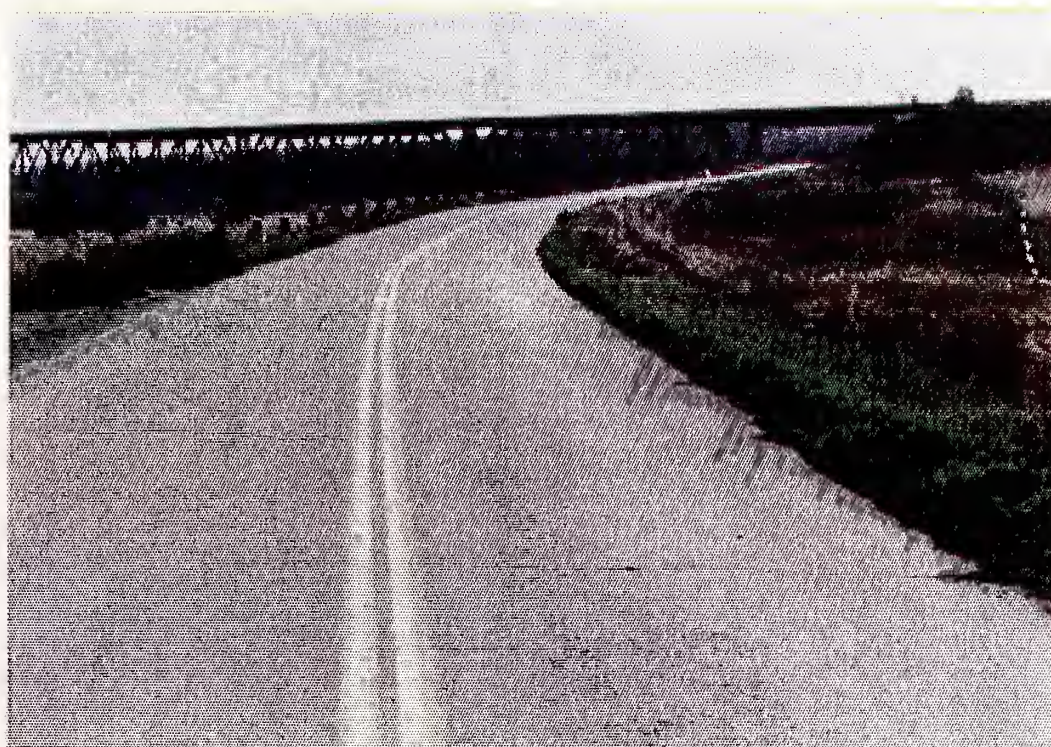
SITE 1: Giant Springs Road approximately .78 miles east of Giant Springs State Park looking east. This location is approximately 300' east of the cutslope in the previous picture. Once the driver clears the cutslope, site distance to the railroad overpass is unrestricted. The type 1 object marker on the left is at the beginning of the cable type guardrail. Note the "W1-1R", with 20 mph advisory speedplate on the right. There are type A+F delineators on the north side of the roadway to and beyond the railroad overpass. (1/18)

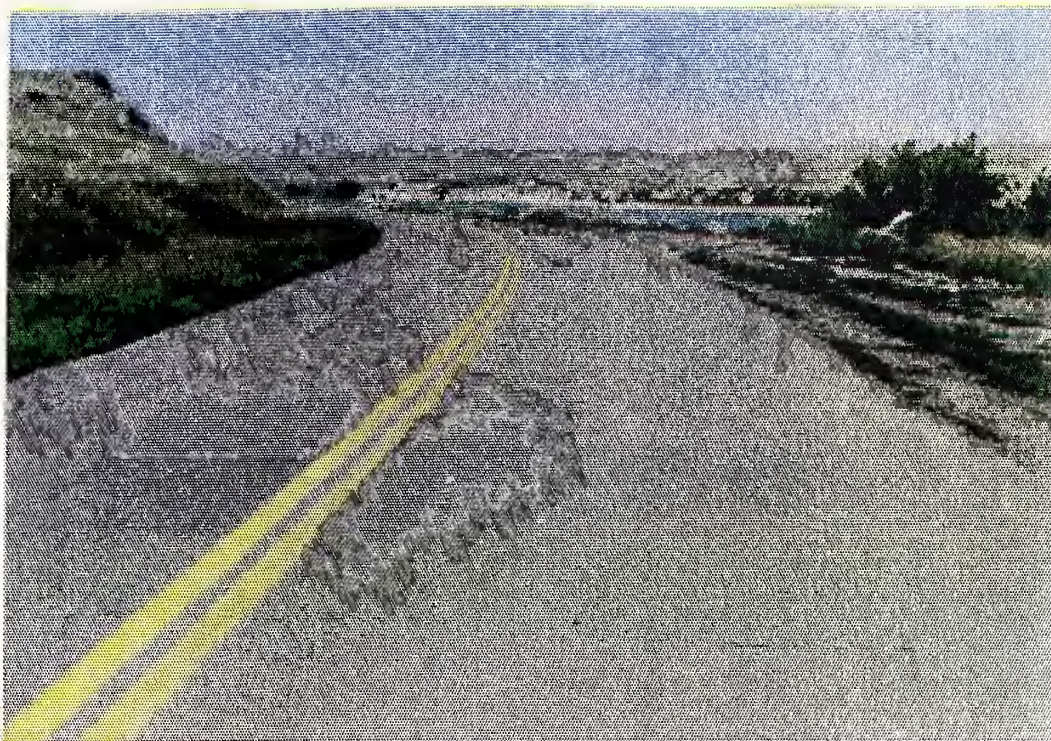
SITE 1: On Giant Springs Rd. near the center of the curve approximately 1,000' west of the railroad overpass looking west. (1/25)

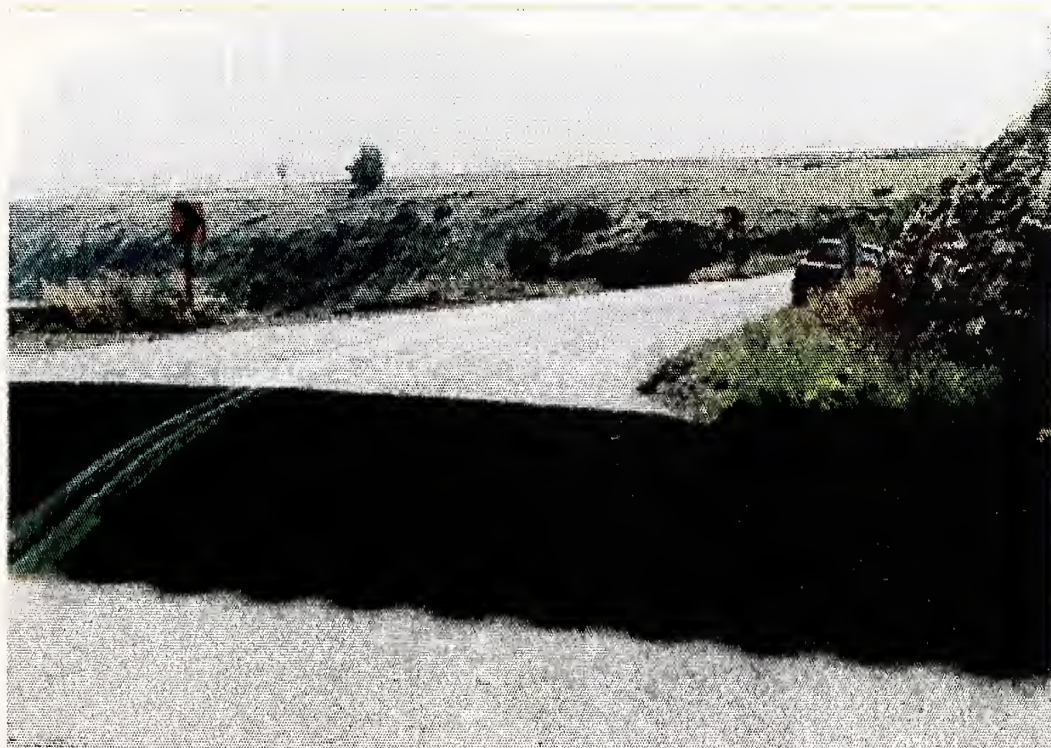
SITE 1: Located approximately 50' west of the railroad overpass across Giant Springs Rd. looking east. This photo is taken from the approximate drivers eye location. (1/20)

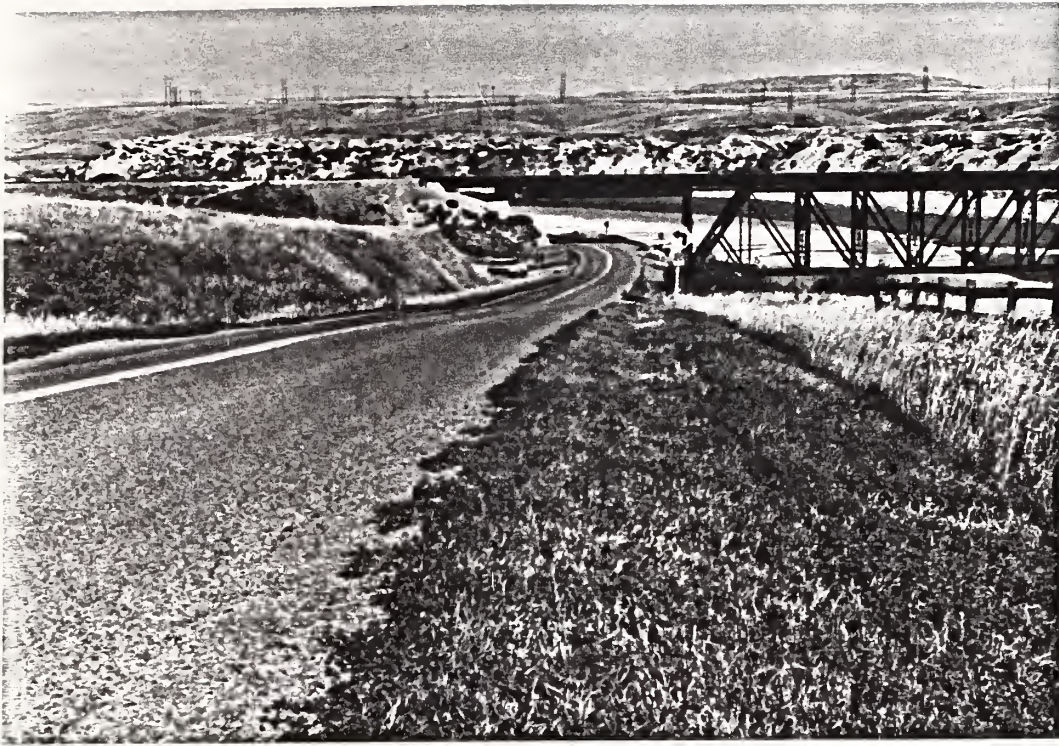
SITE 1: On Giant Springs Rd. approximately 1.1 miles east of Giant Springs State Park. Note the hillside and railroad overpass on the left. (1/22)

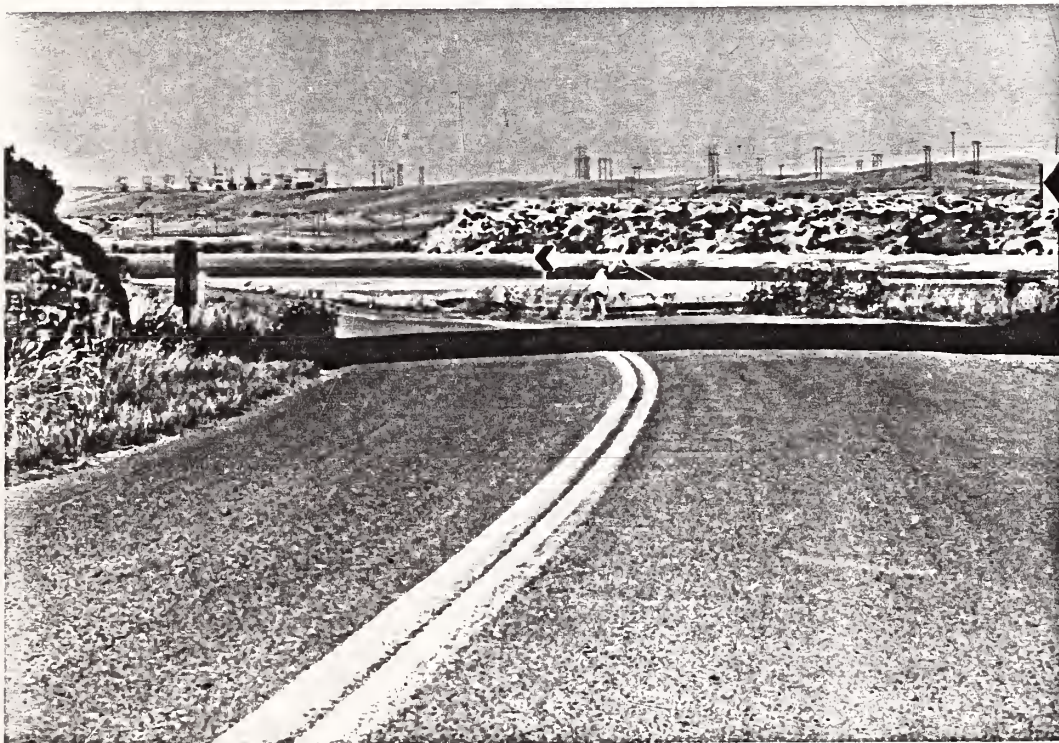
SITE 1: On Giant Springs Rd. approximately 40' east of the railroad underpass looking west. (1/23)

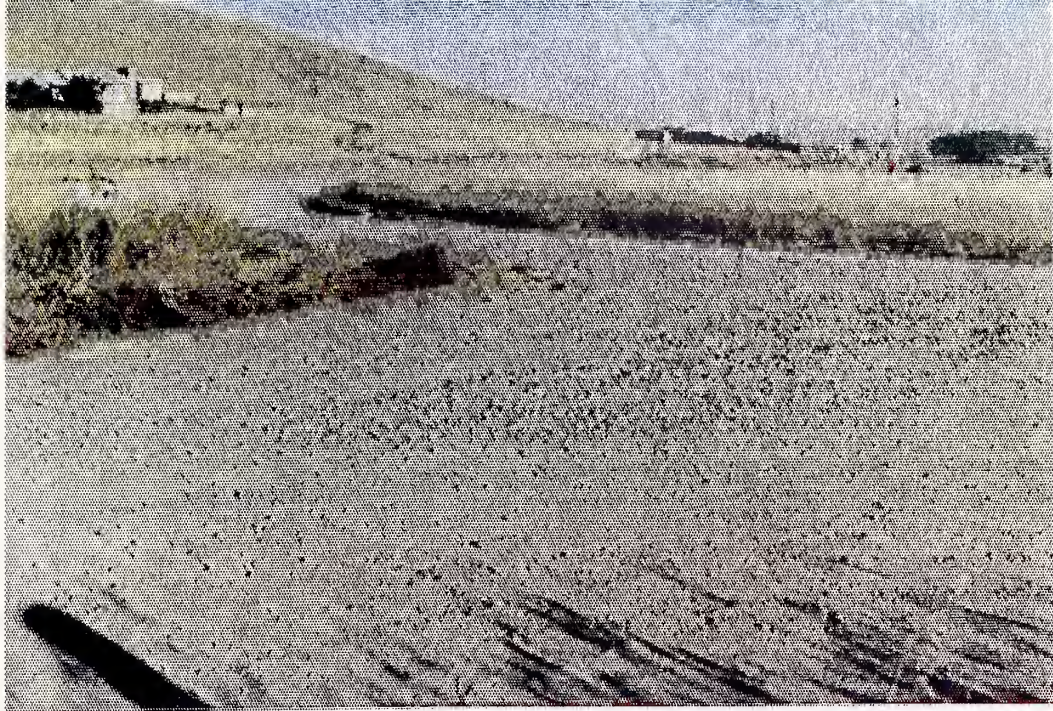
SITE 2: Taken near the PC of the south westbound curve to the right from a gravel driveway approach looking northwest. (4/24)

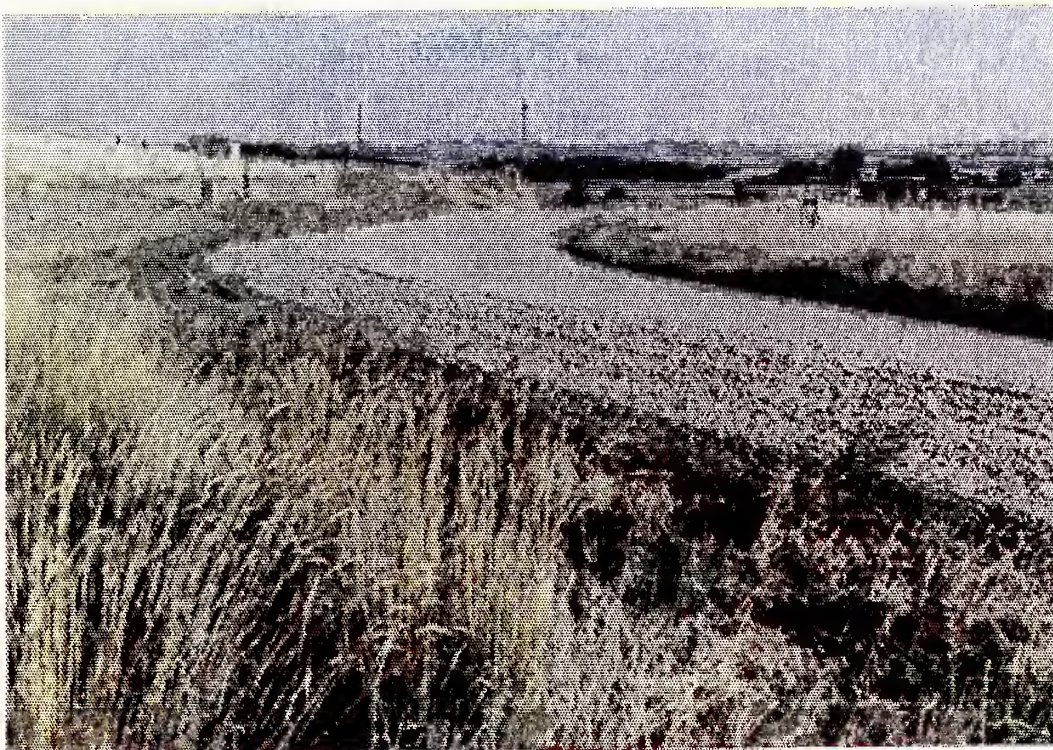
SITE 2: Taken on McIver Road approximately midway through the south curve looking northwest. (5/3)

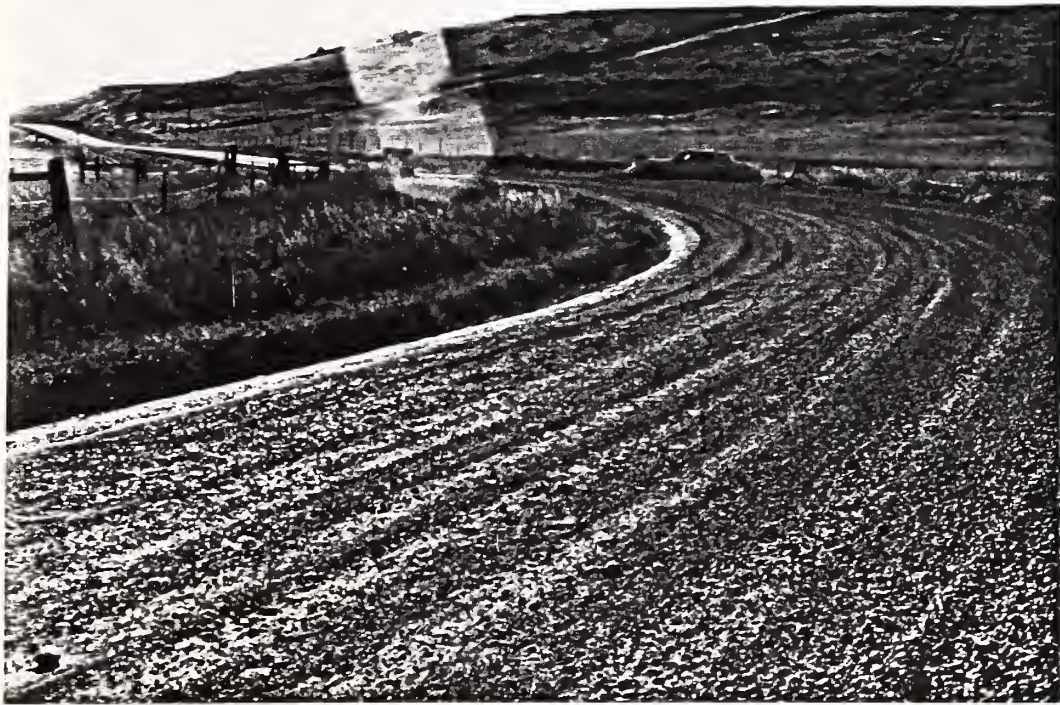
SITE 2: Taken on McIver Road at the PC of the north curve to the left looking southeast. (5/9)

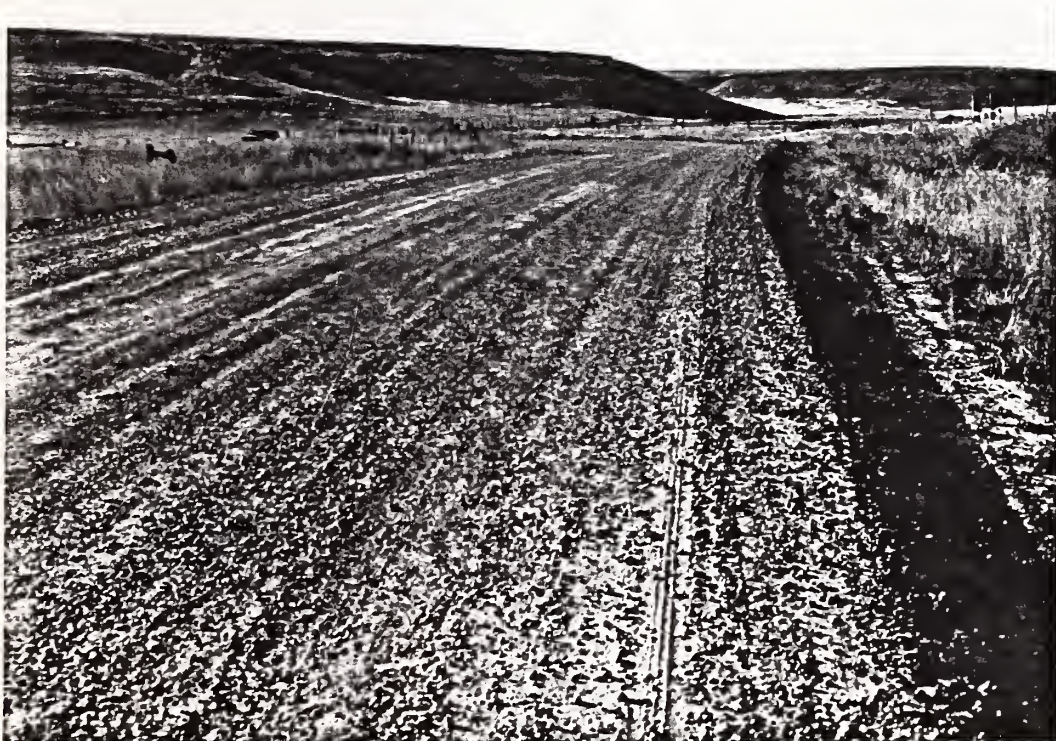
SITE 2: Taken on McIver Road at the PC of the north curve looking south. (5/7)

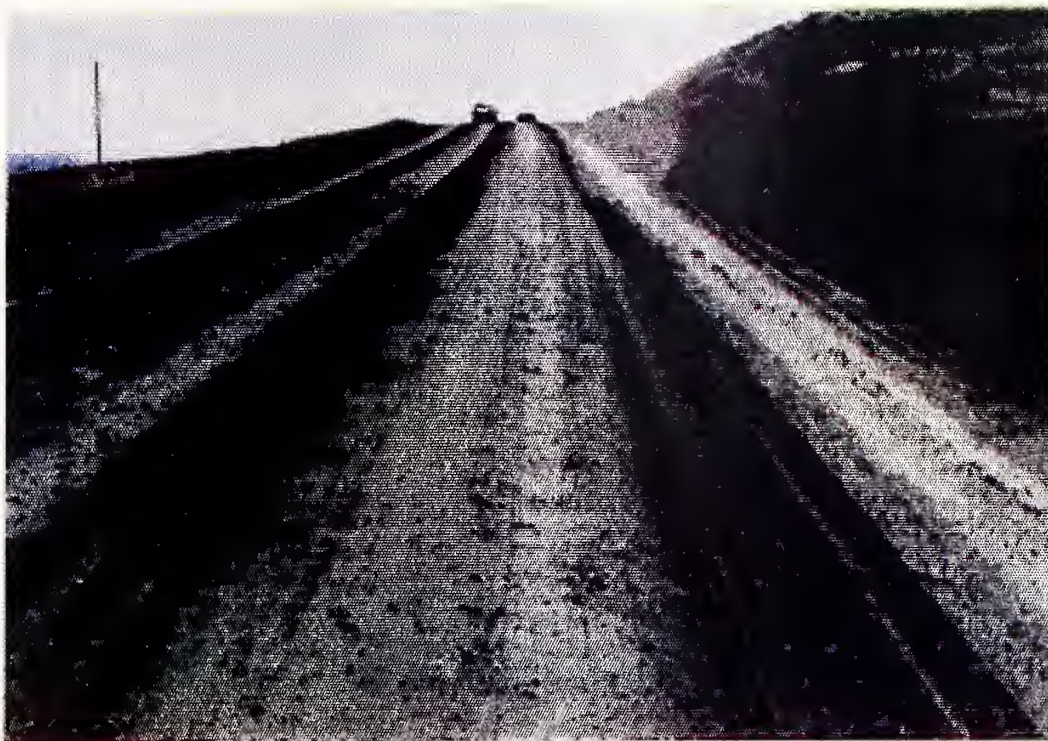
SITE 2: On McIver Road just west of the crest vertical curve looking east at the crest vertical curve. (5/12)

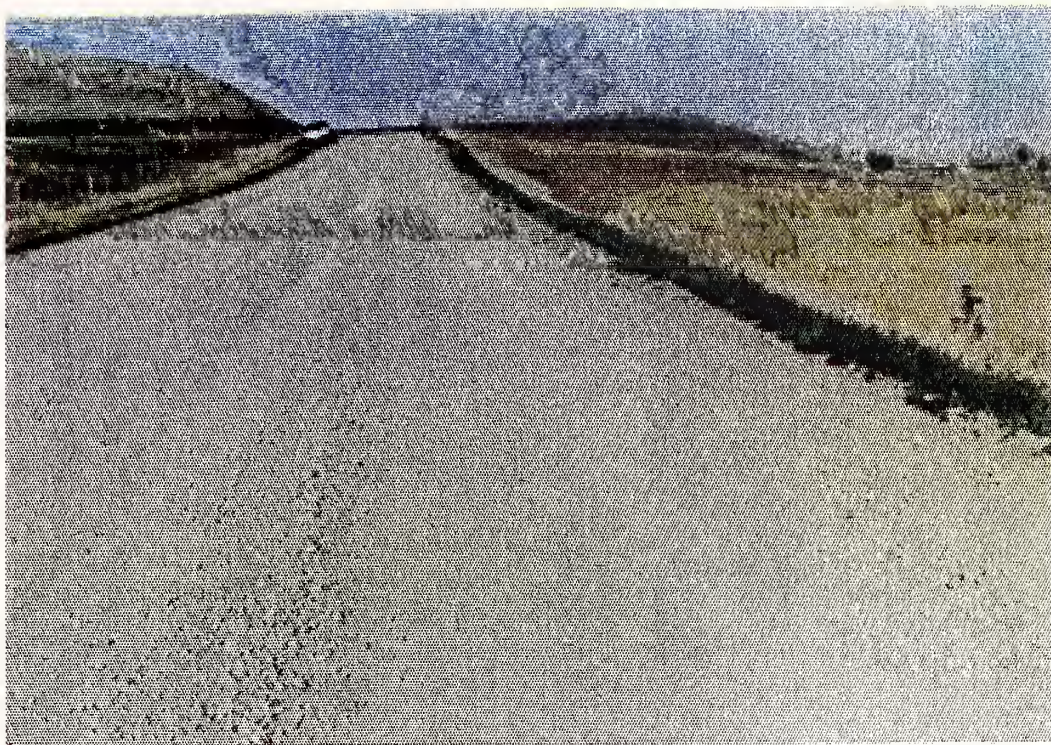
SITE 2: On McIver Road near the east base of the crest vertical curve looking west. (5/15)

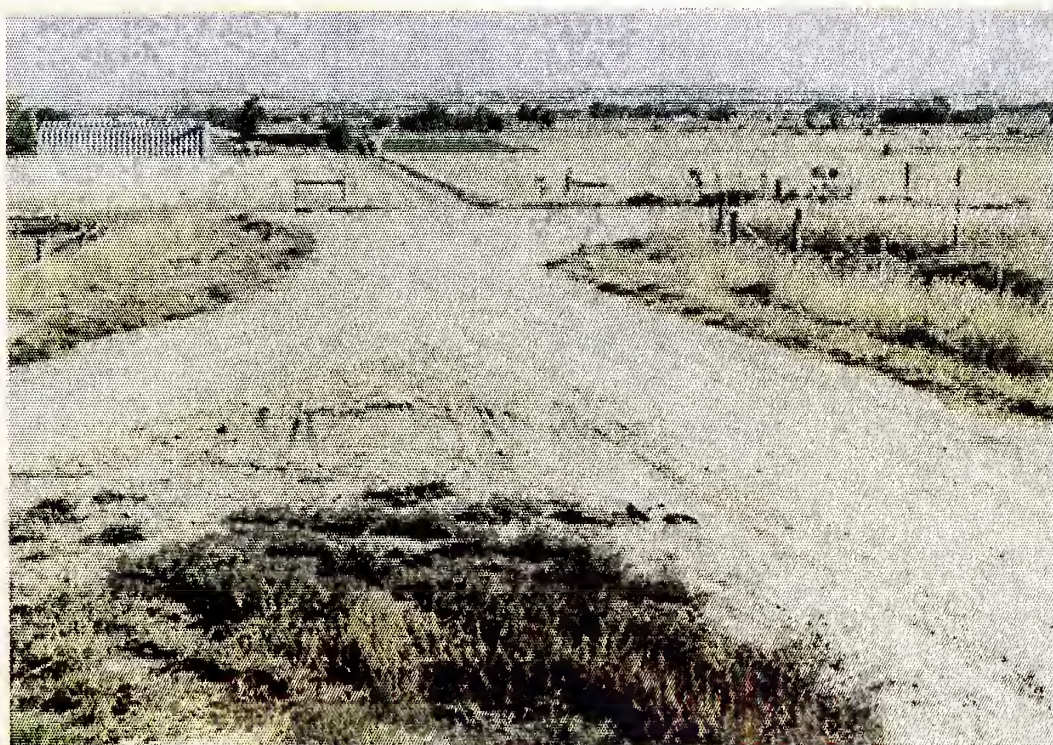
SITE 2: Station 0+00 at approximately 200' south of McIver Road looking north. (5/16)

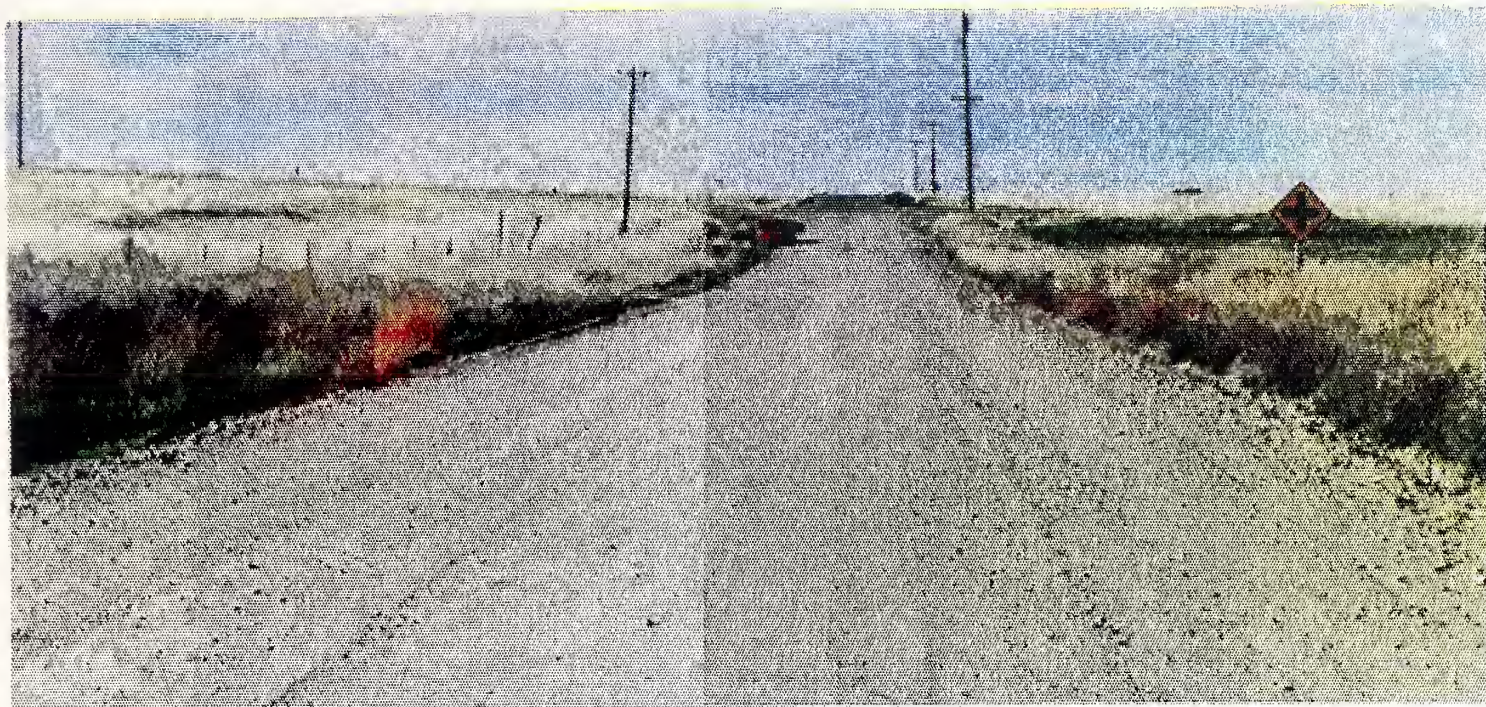
SITE 3: From 26th St. S approximately 450' south of Gibson Flats Road looking north. The black sports car is in the right turn only lane in the northeast quadrant of the intersection. (1/1+2)

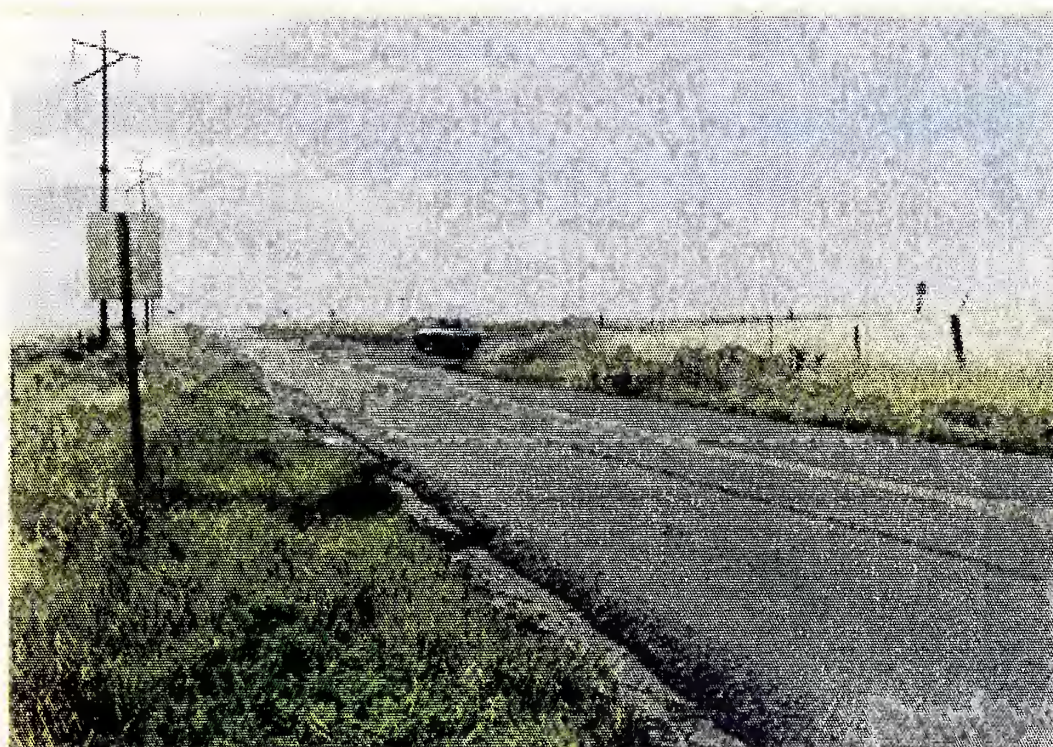
SITE 3: From Gibson Flats Road approximately .05 miles east of 26th St. S looking west. The speed limit sign is in the left foreground and there is a southbound to eastbound auto making the illegal left turn maneuver. This vehicle is turning the wrong way down the westbound to northbound right turn only lane. (1/5)

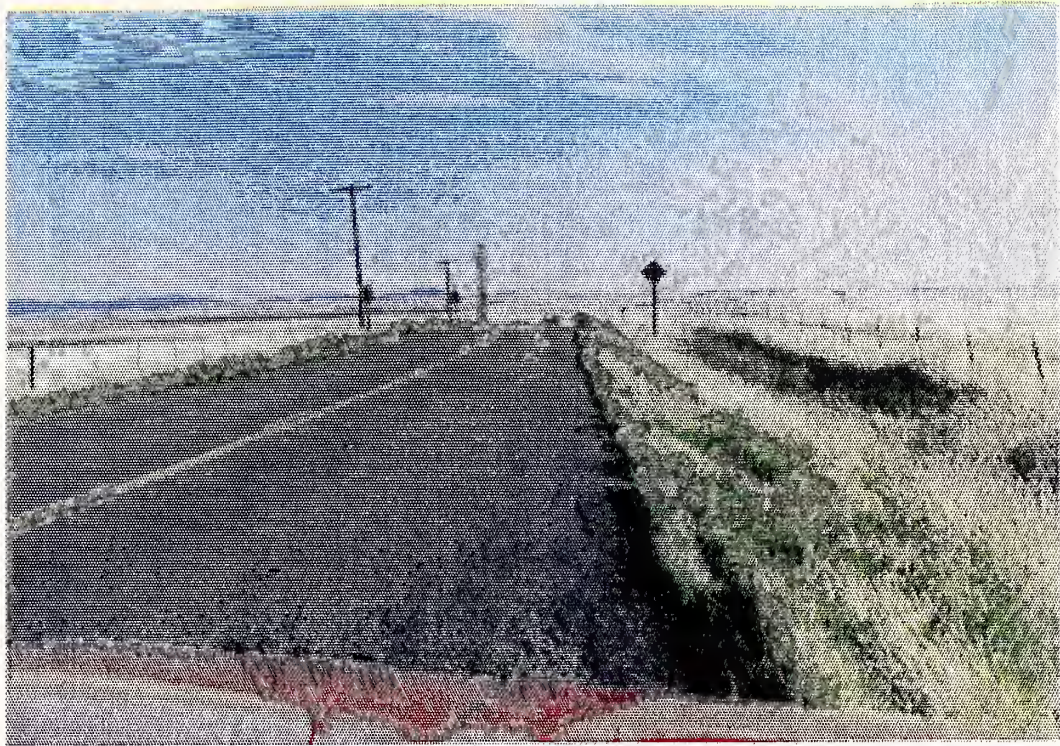
SITE 3: On 26th St. S looking south in advance of Gibson Flats Road from the approximate drivers eye position. Note the disappearance of the vehicle over the crest of the hill in advance of Gibson Flats Road. (1/6)

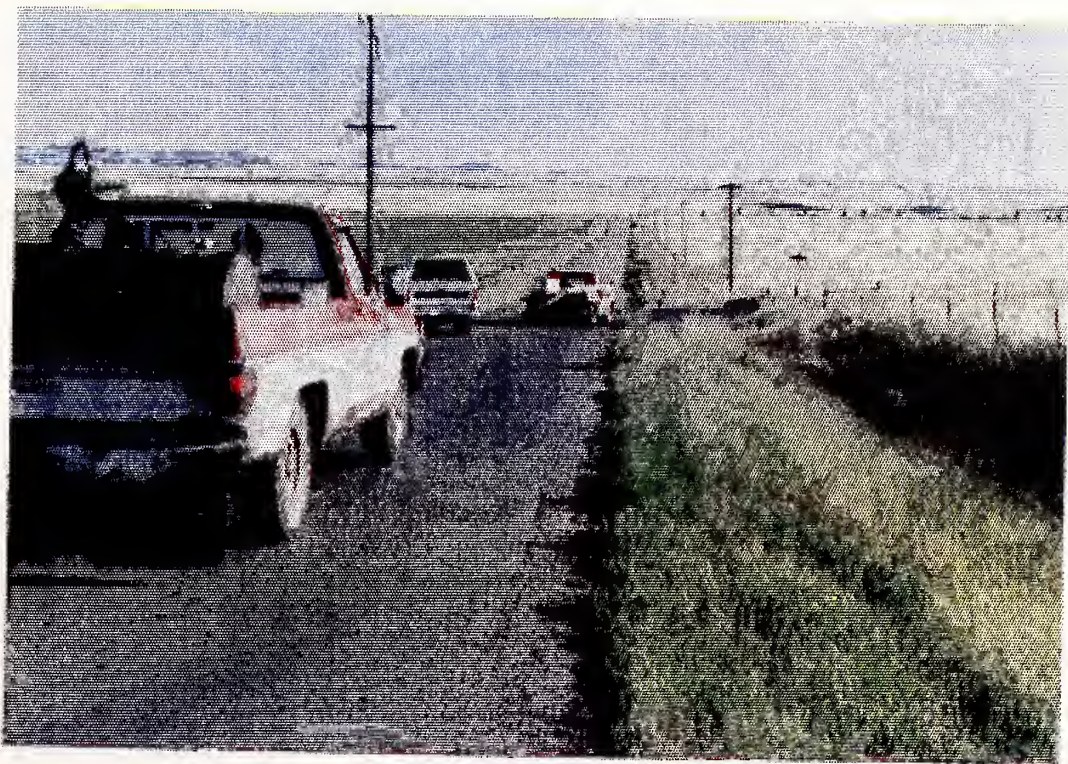
SITE 3: From 26th St. S approximately 200' north of the intersection with Gibson Flats Road looking south. (1/8)
